St Paul Lutheran Church

Roof Project Information

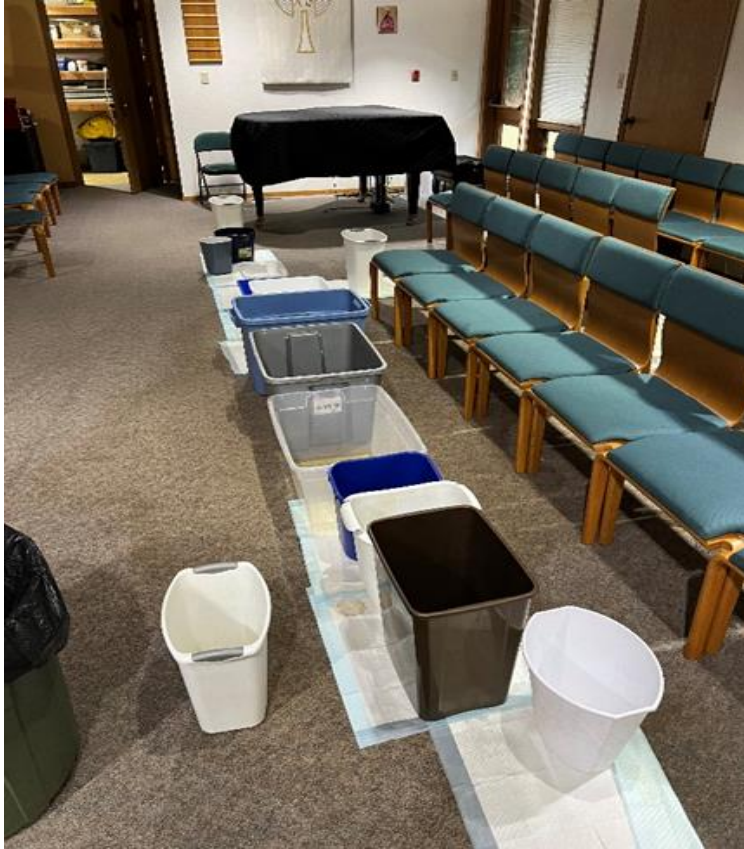
Figure 2

Trying to catch drips and keep carpet dry

There were times it was almost like it was raining inside the Sanctuary, even when the weather outside was clear and sunny. We have had the roof worked on several times to fix these leaks, however the leaks never stopped and in fact continued to become worse.

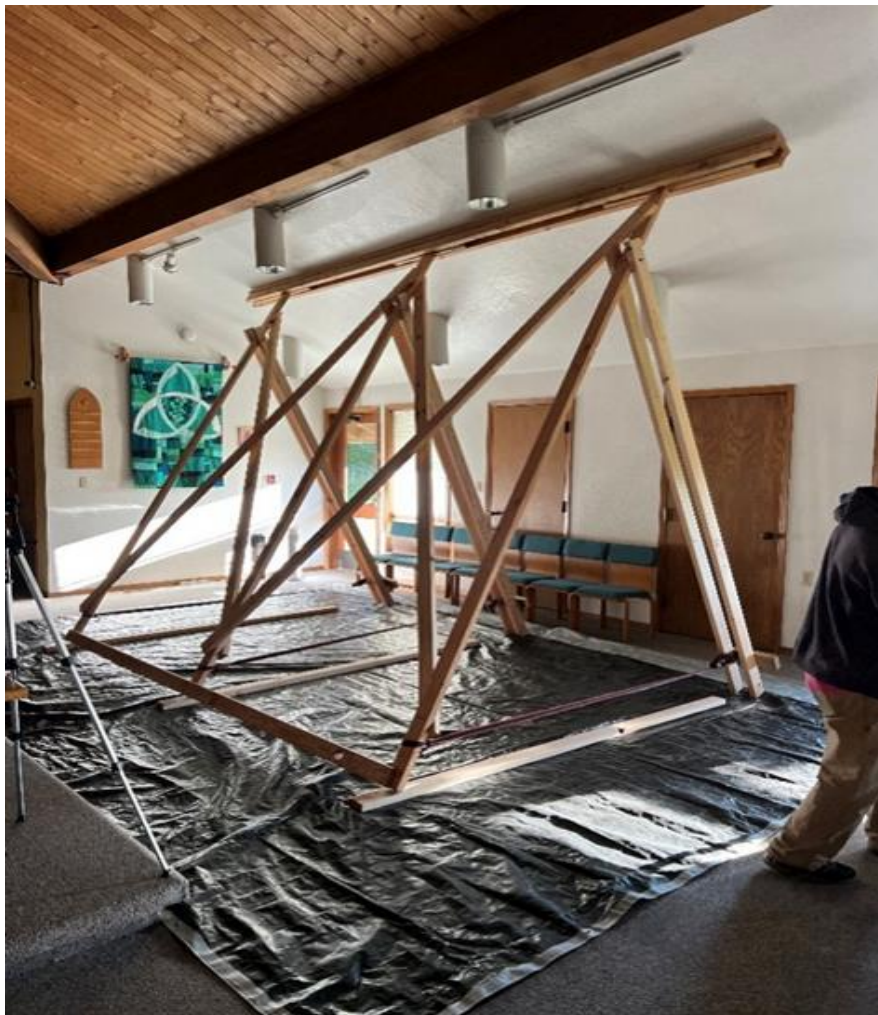
*Figure 3
Rafter support frame supporting the rafters during temporary repairs*

The roof was found to be spongy and soft when stepped on, so we constructed a large frame inside the sanctuary to support the roof before we started.

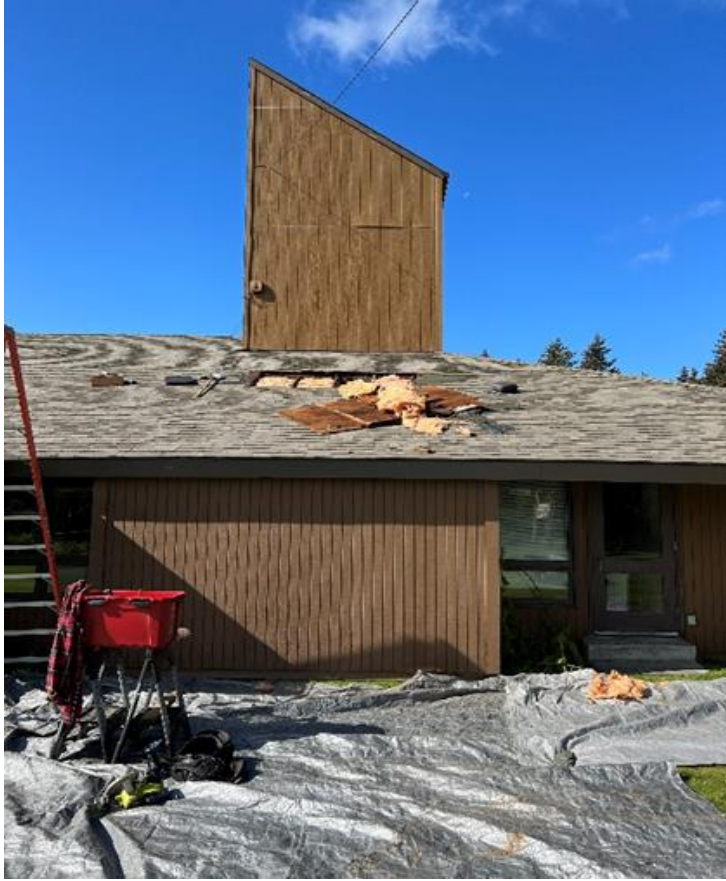
Figure 4
First piece of sheathing removed

The shingles were removed. The sheathing was completely soaked and softened from rot.

The piece of sheathing was removed and revealed that the rafters were also soaked from the top down. They were rotten to the point that they were starting to crumble. The insulation was completely soaked and there was water standing on the vapor barrier. Several more sheets of the plywood sheathing were removed and revealed the same conditions.

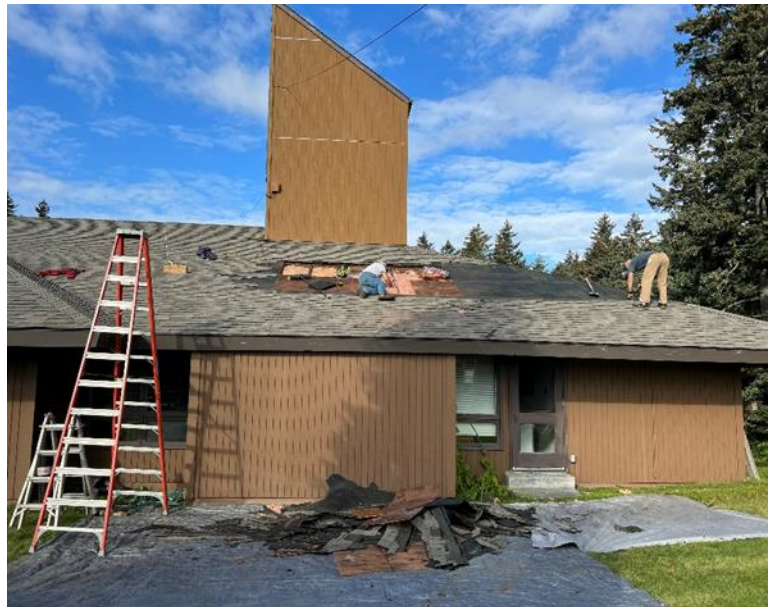
portion of the solid roof was also viewed and though wet, it appeared to be structurally sound at that time. Because it was so late in the year, we knew that no permanent repair could be made so a temporary repair was done to carry us through the winter so that snow load would not cause the roof to collapse in that area.

Figure 5
Temporary Repairs

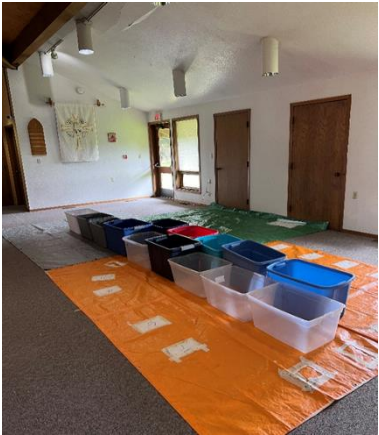
Figure 6

Currently catching the drips and waiting for the contractor to start.

Phase 1 of the roof reconstruction plan will take place this summer. This phase will be to replace the East side of the sanctuary roof, which is the portion that we believe has the most significant rot. The estimate for this repair is \$124,455 (plus any overruns for any additional problems encountered). When we calculated that the repair to the West and North sides of the sanctuary (phases 2 & 3) could potentially each cost the same amount and that the repair of the steeple and the replacement of the remainder of
